Technical Report CHL-97-30  
October 1997

# **Navigation Conditions at Point Marion Lock and Dam, Monongahela River**

## **Hydraulic Model Investigation**

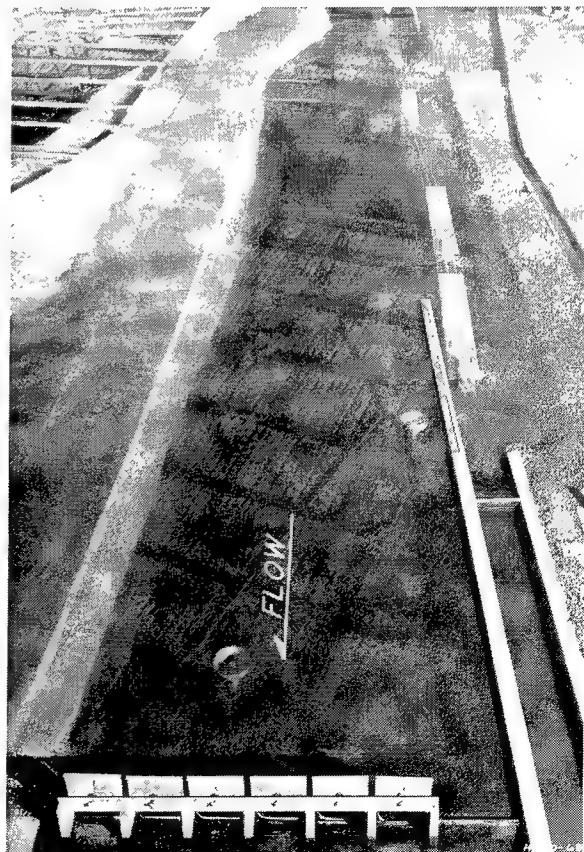
Photo 16. Plan B, looking upstream, discharge 55,000 cfs, showing path of upbound tow leaving lock

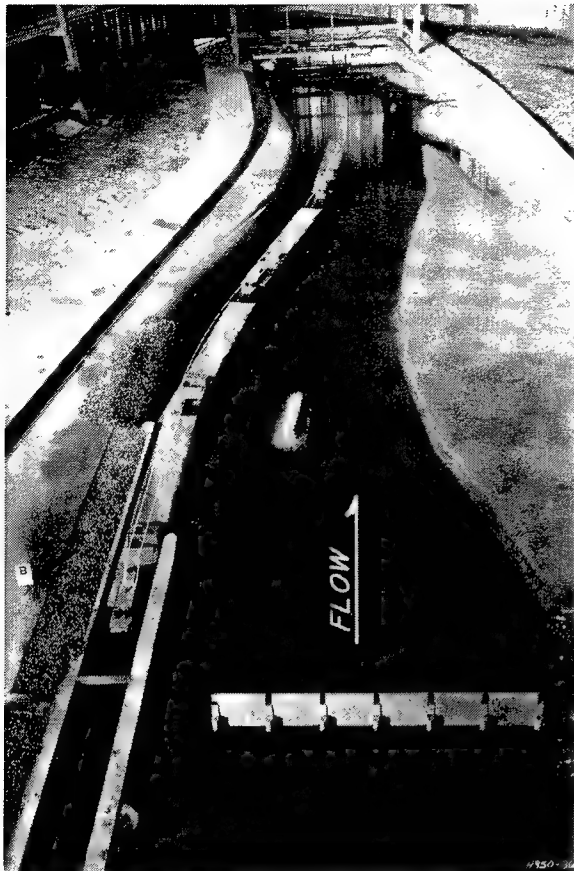
Photo 17. Plan B, looking downstream, discharge 22,500 cfs, showing path of downbound tow leaving lock near midchannel

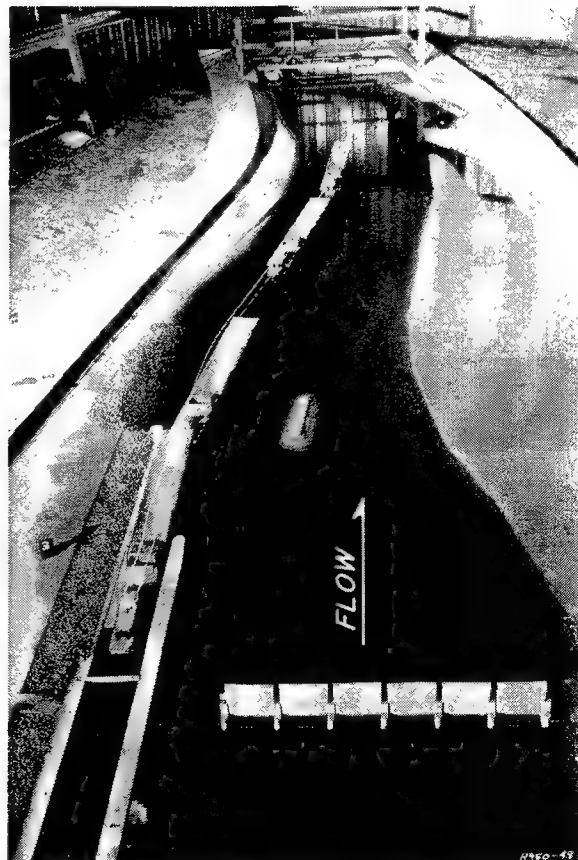
Photo 18. Plan B, looking downstream, discharge 55,000 cfs, showing path of downbound tow leaving lock

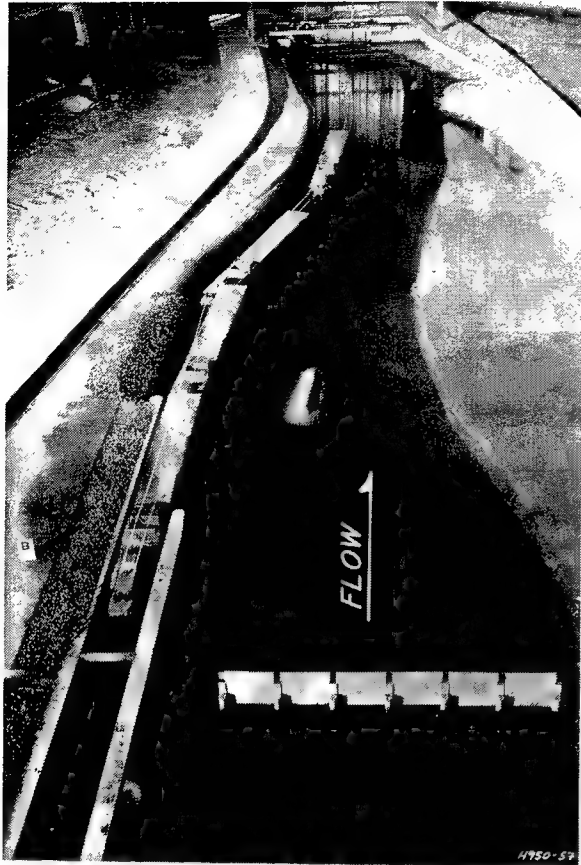
Photo 19. Plan B, looking downstream, discharge 22,500 cfs, showing path of downbound tow leaving lock along left bank

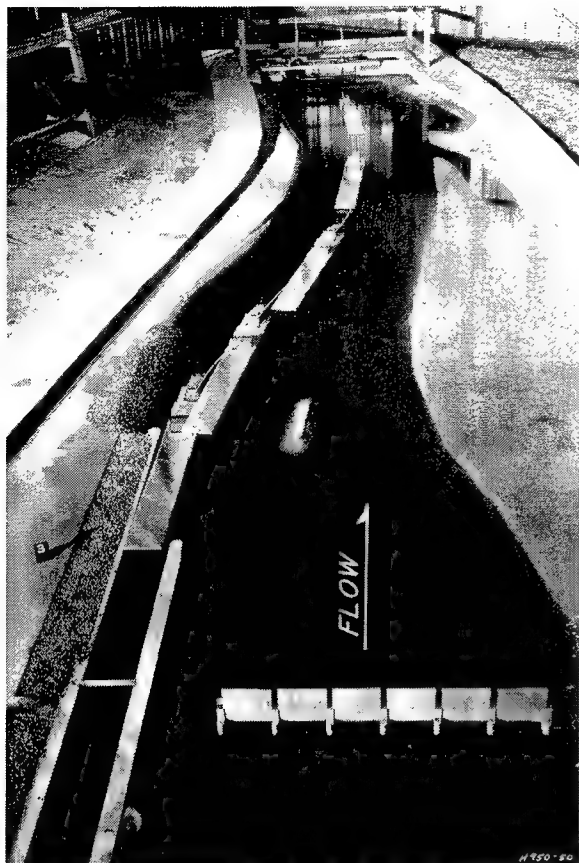
Photo 21. Plan B, looking downstream, discharge 55,000 cfs, showing path of upbound tow approaching lock from midchannel

(Photo 15). The tow could make a slow approach to the guard wall without any tendency for the tow to be moved out of the approach or for the head of the tow to move into the wall with excessive force. No difficulties were indicated for upbound tows leaving the lock. An upbound tow could move away from the guard wall and navigate upstream along the left bank (Photo 16) or move out into the main channel without any difficulties. Because the currents were moving across the lower lock approach, a downbound tow was required to rotate the head of the tow away from the guide wall about 15 deg before leaving the lower approach. After rotating the head of the tow off the guide wall, the tow could drive away from the lower approach and enter the main channel without any difficulties (Photos 17 and 18). Maneuvering the head of the tow away from the guide wall required additional time but was not a difficult maneuver. If the tow moved downstream without maneuvering the head of the tow off the wall, the clearance between the tow and the left bank was minimal for the tow to turn toward the main river channel, and the stern of the tow could ground on the left bank (Photo 19). Upbound tows could leave the main river channel and approach the lower guide wall without any major difficulties (Photos 20 and 21).

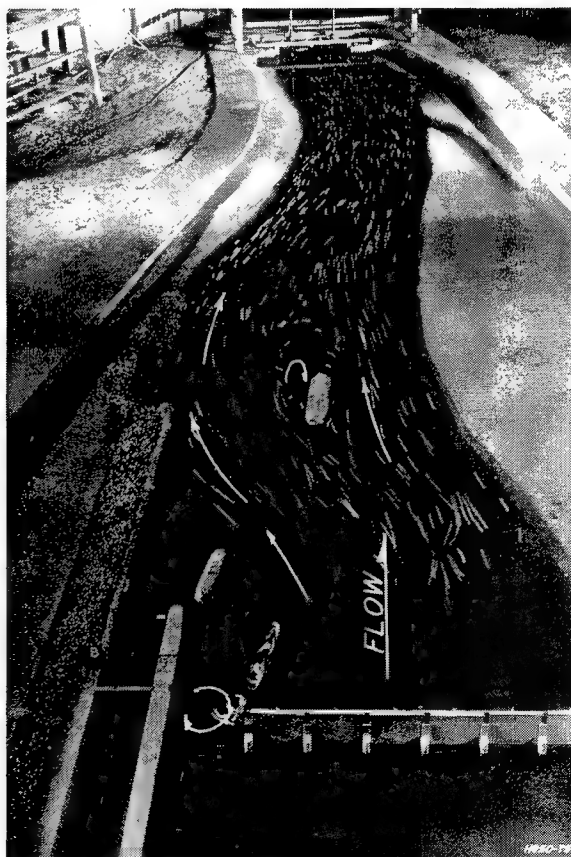
Photo 22. Plan B-Modified, looking downstream, discharge 22,500 cfs, confetti showing surface current patterns in the lower approach to the lock

**Current directions and velocities.** Current direction and velocity data shown in Plate 9 and current patterns shown in Photos 22 and 23 indicate that the flow through the spillway moved between the vane dike near the end of the riverside lock wall and the vane dike near midchannel and across the lower lock approach at a steep angle. Some flow passed through the opening between the vane dike and the downstream end of the riverside lock wall. However, a small counterclockwise eddy formed immediately downstream of the lock chamber (Plate 9). The velocity of the current in the eddy varied from less than 0.5 to about 1.7 fps with the 33,000- and 55,000-cfs riverflows, respectively. The maximum velocities of the current near the downstream end of the guide wall varied from about 3.4 to 4.0 fps with the 22,500- and 55,000-cfs riverflows,

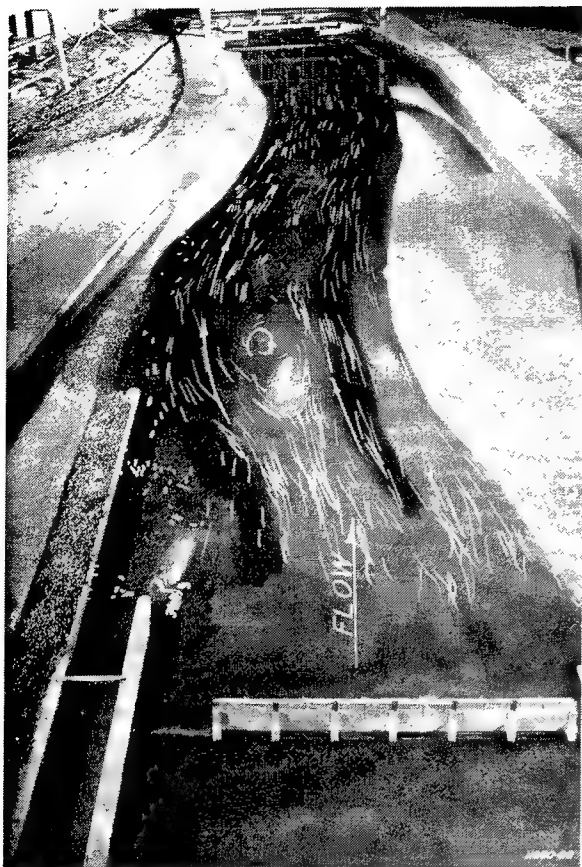
Photo 23. Plan B-Modified, looking downstream, discharge 55,000 cfs, confetti showing surface current patterns in the lower approach to the lock

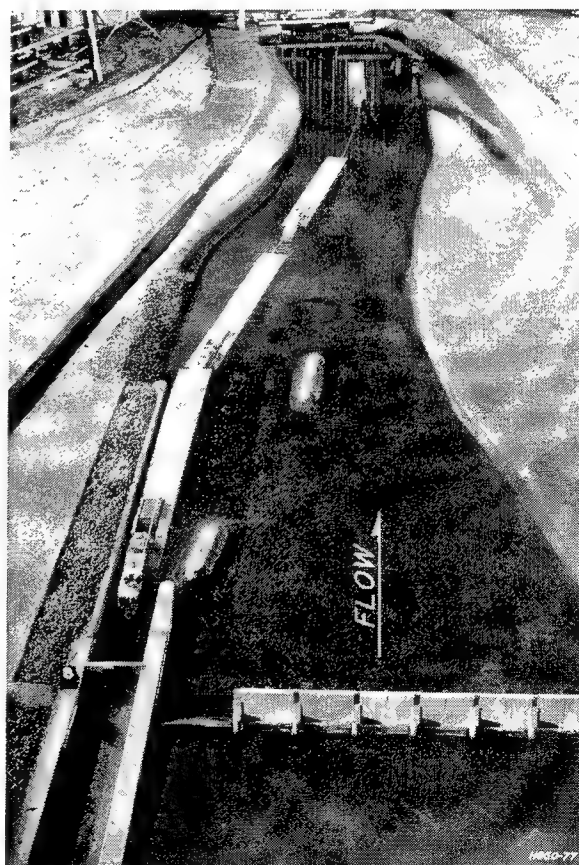
Photo 24. Plan B-Modified, looking downstream, discharge 22,500 cfs, showing path of downbound tow leaving lock

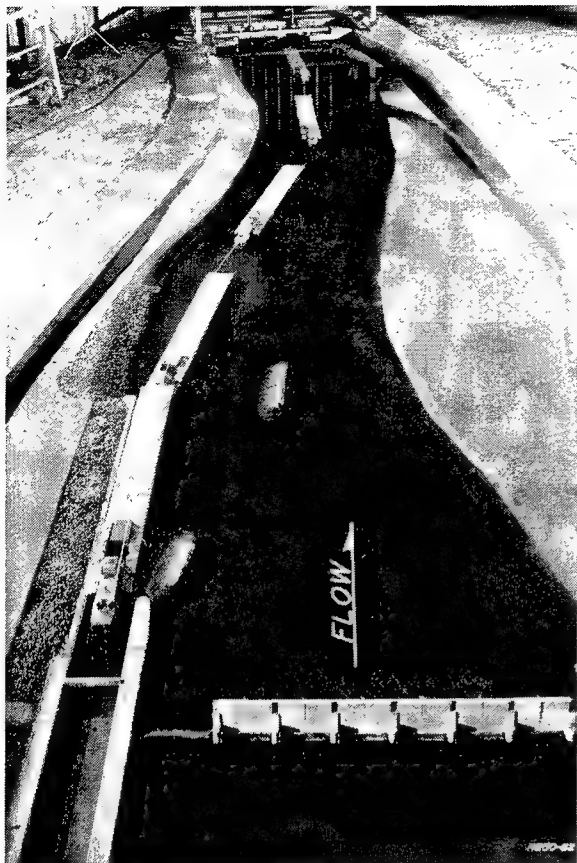
Photo 25. Plan B-Modified, looking down-stream, discharge 55,000 cfs, showing path of downbound tow leaving lock

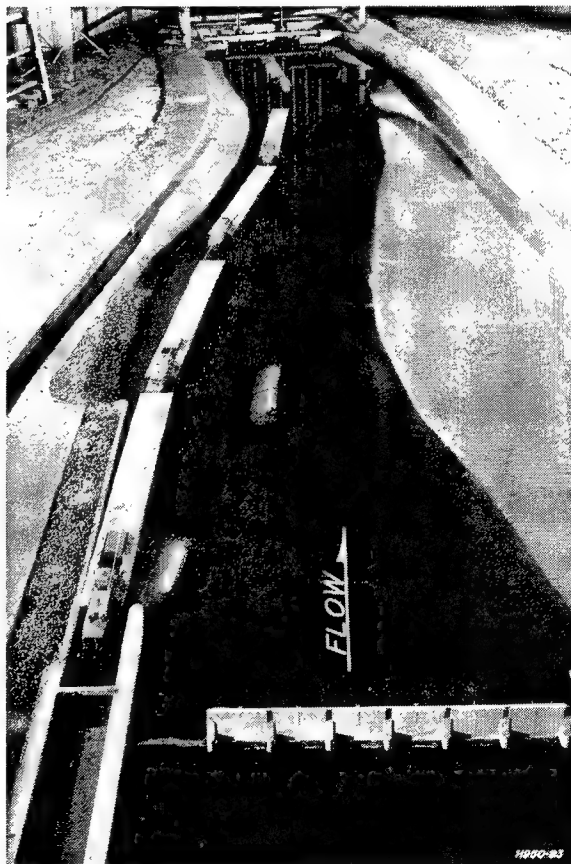
Photo 26. Plan B-Modified, looking down-stream, discharge 55,000 cfs, showing path of downbound tow leaving lock along left bank

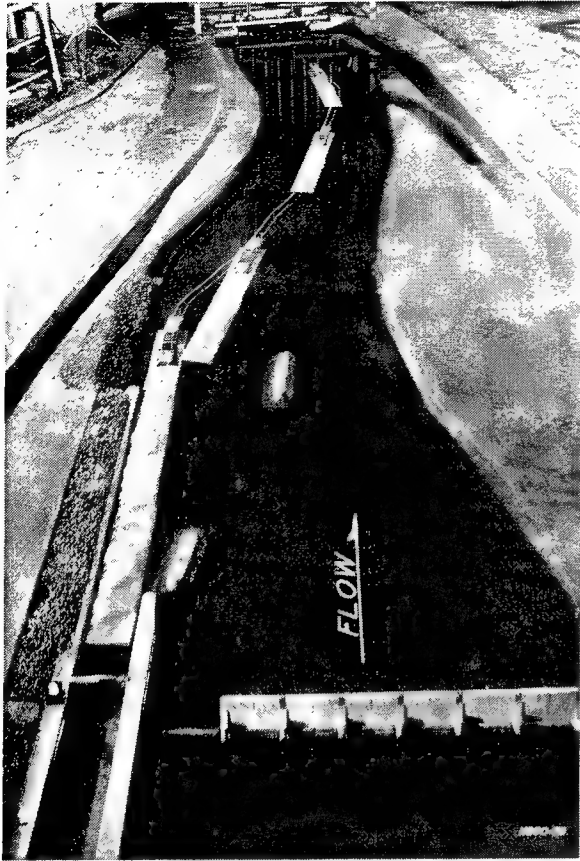
Photo 27. Plan B-Modified, looking downstream, discharge 22,500 cfs, showing path of upbound tow approaching lock from midchannel

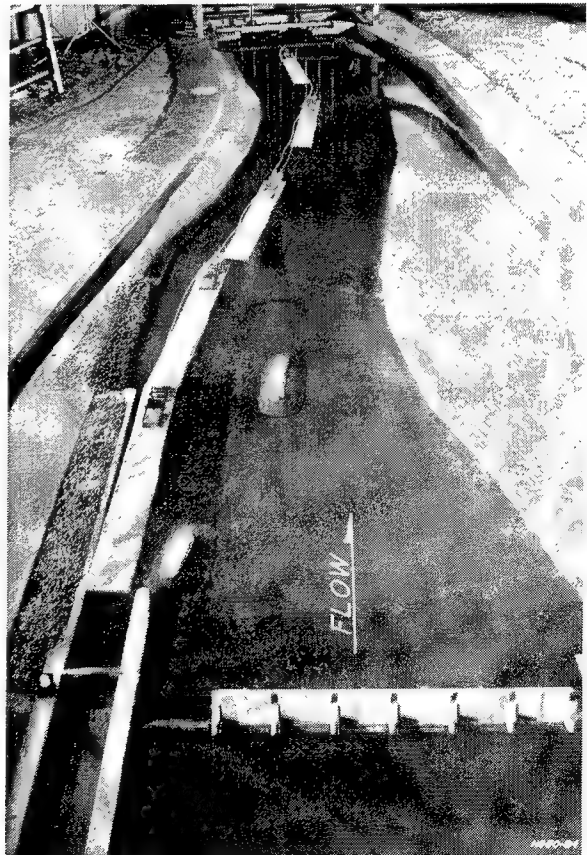
Photo 28. Plan B-Modified, looking downstream, discharge 50,000 cfs, showing path of upbound tow approaching lock

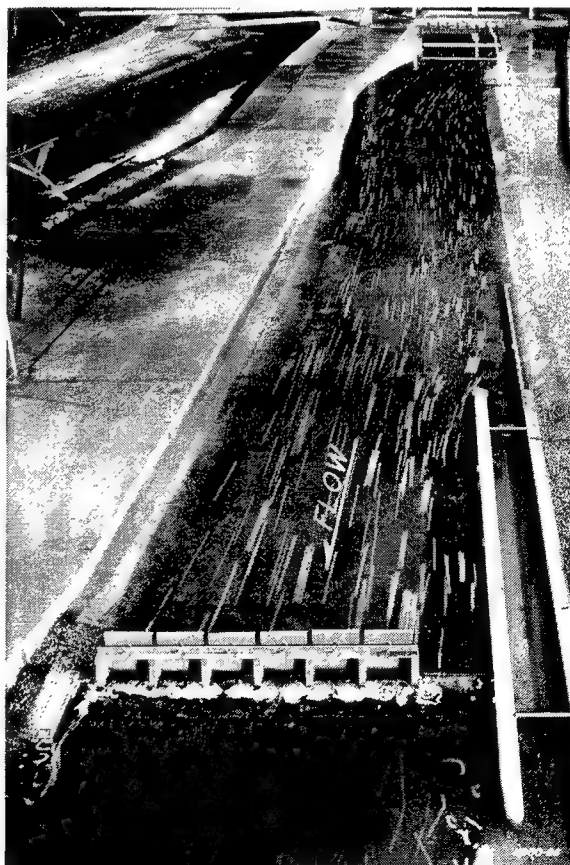
Photo 29. Plan D, looking upstream, discharge 22,500 cfs, confetti showing surface current patterns in the upper approach to the lock

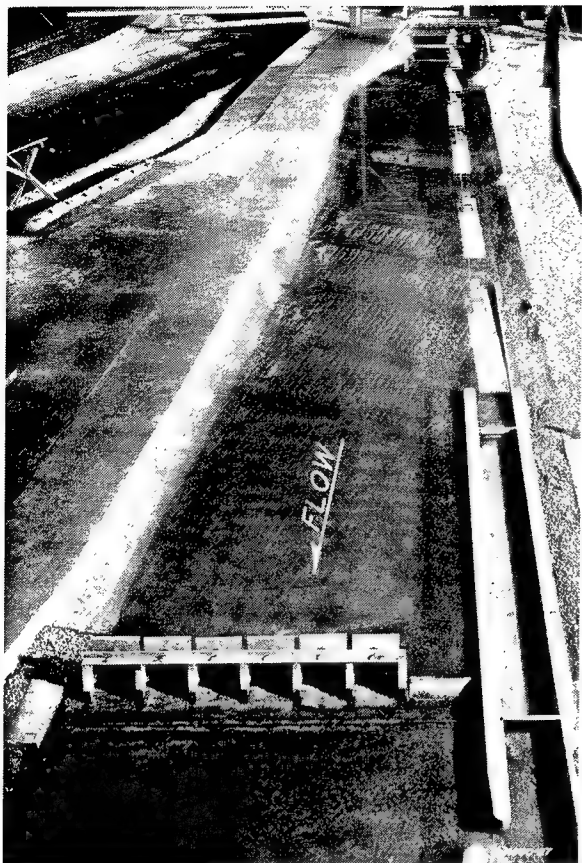
Photo 30. Plan D, looking upstream, discharge 55,000 cfs, confetti showing surface current patterns in the upper approach to the lock

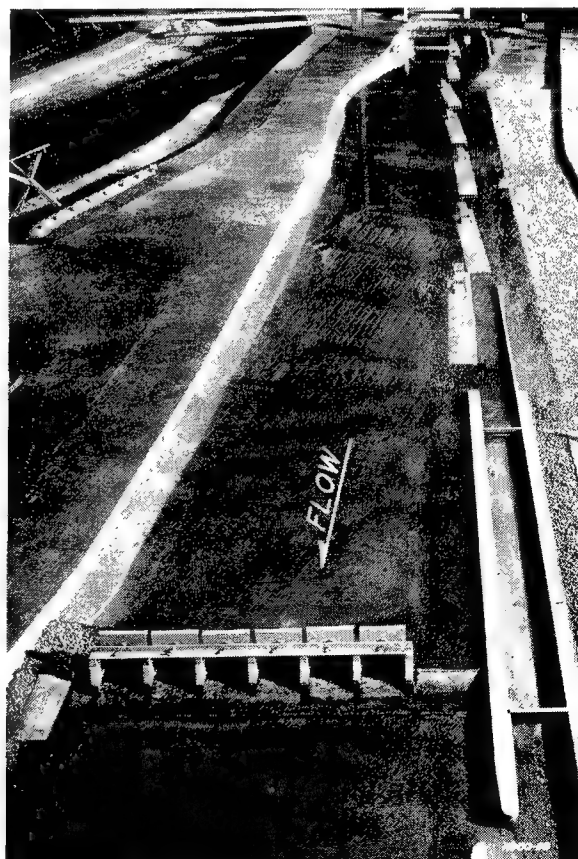
Photo 31. Plan D, looking upstream, discharge 22,500 cfs, showing path of downbound tow approaching lock

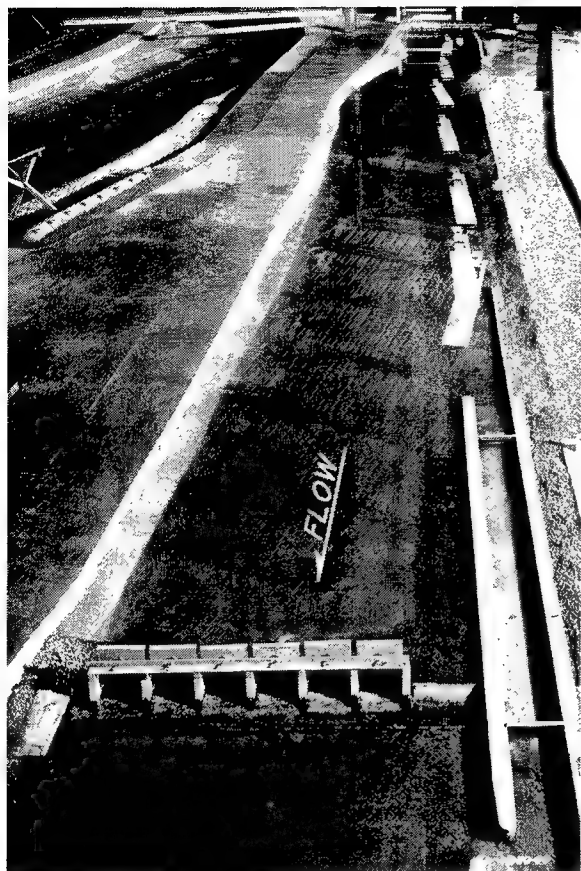
Photo 32. Plan D, looking upstream, discharge 55,000 cfs, showing path of downbound tow approaching lock. Note movement away from guide wall as tow reduces speed

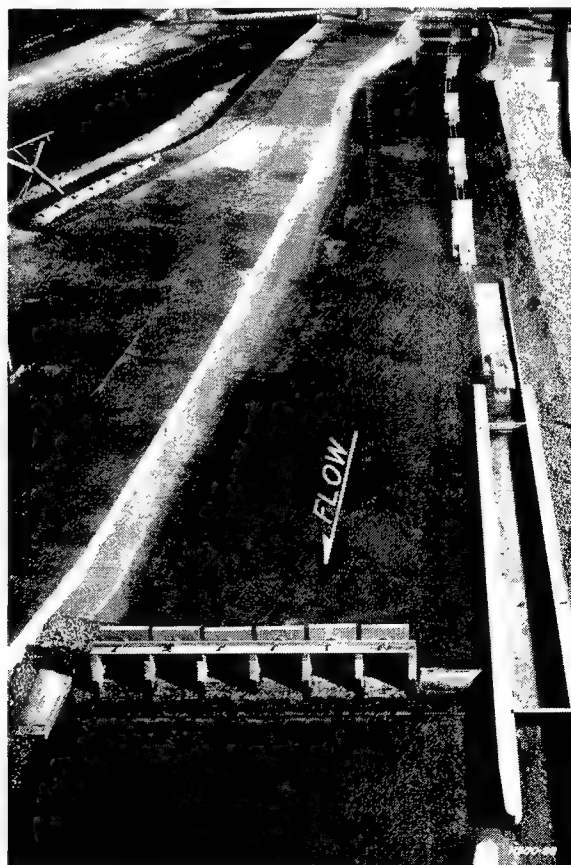
Photo 33. Plan D, looking upstream, discharge 55,000 cfs, showing path of downbound tow approaching lock. Note maneuvering in approach

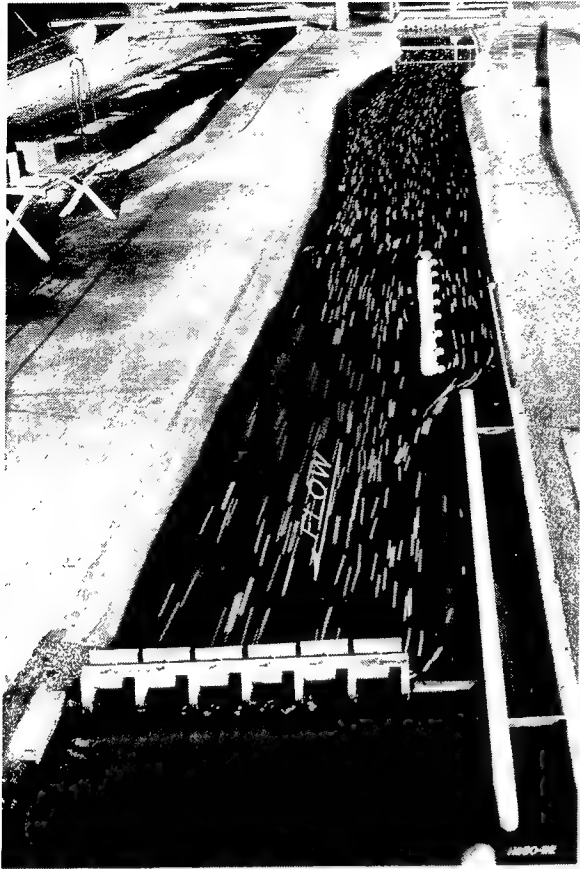
Photo 34. Plan D, looking upstream, discharge 22,500 cfs, showing path of upbound tow leaving lock

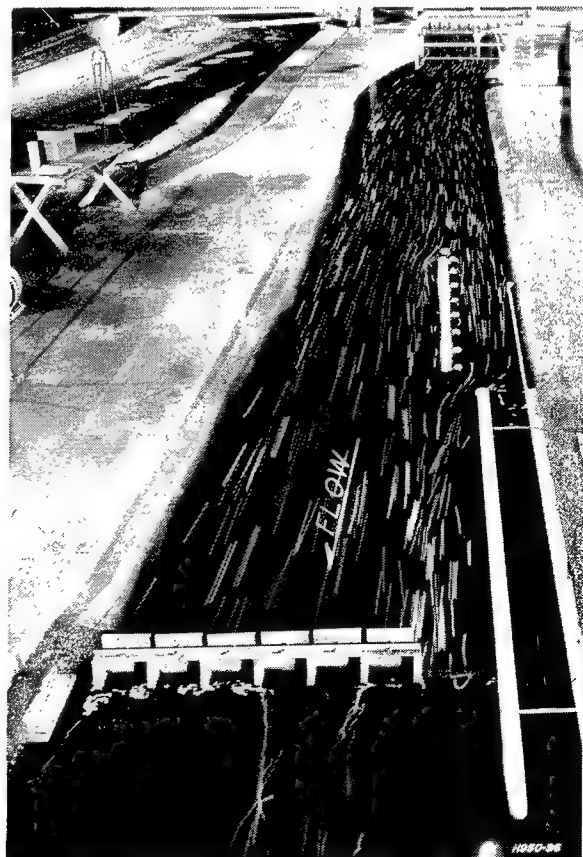
Photo 35. Plan D-Modified, looking upstream, discharge 22,500 cfs, confetti showing surface current patterns in the upper approach to the lock

**Current directions and velocities.** Current direction and velocities obtained with Plan D-Modified are shown in Plate 15. Confetti showing surface current patterns are shown in Photos 35 and 36. The current generally followed the left bank from the upstream end of the model into the lock forebay. The

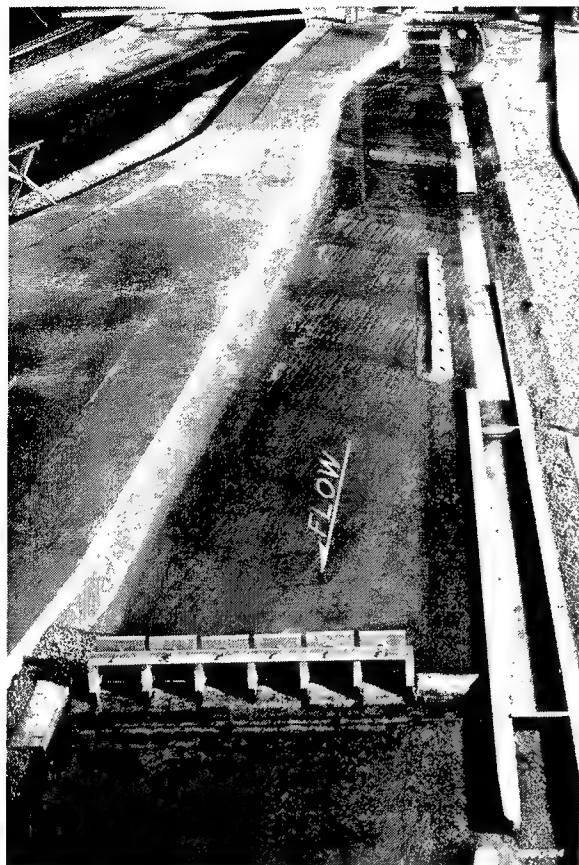
Photo 36. Plan D-Modified, looking upstream, discharge 55,000 cfs, confetti showing surface current patterns in the upper approach to the lock

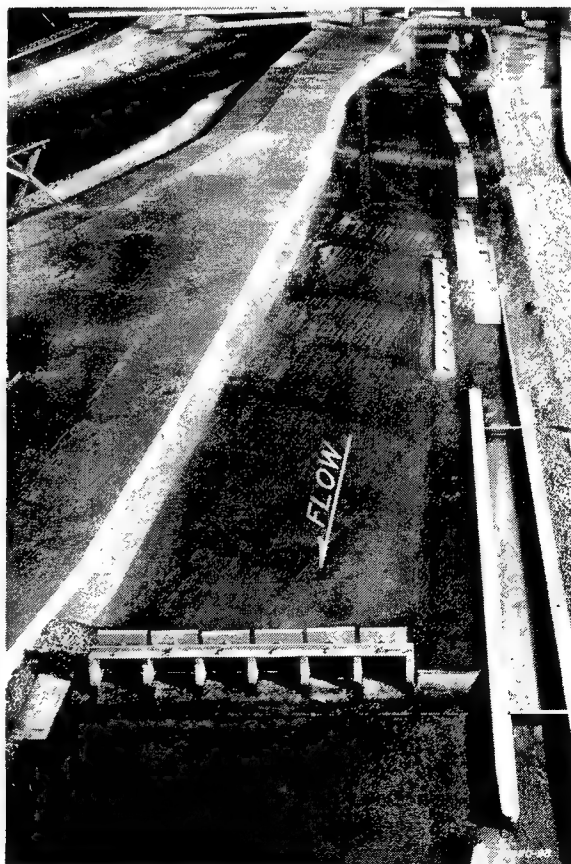
Photo 37. Plan D-Modified, looking upstream, discharge 22,500 cfs, showing path of downbound tow approaching lock

**Navigation conditions.** The longitudinal dike reduced the outdraft along the upper guide wall observed in Plan D with all flows and allowed the tow to land on the guide wall about 300 ft downstream of its upstream end. The opening between the dike and the riverward lock wall allowed some flow to enter the lock approach and prevented an extreme outdraft from forming near the upstream end of the dike. A downbound tow could enter the model reach near midchannel, drive to the left bank downstream of the mooring cells, and align with the guide wall three to four tow lengths upstream of the guide wall. With the 22,500-cfs riverflow, a downbound tow could align with the guide wall, reduce speed, and land on the guide wall with no major difficulties (Photo 37). However, as the tow moved along the guide wall to enter the lock chamber, there was a tendency for the head of the tow to be moved away from the wall by the flow passing through the opening between the riverward lock wall and the dike. As the riverflow increased to 55,000 cfs, there was a tendency for the current to move the tow away from the guide wall and toward the cells as it entered the lock forebay. The tow could maneuver to the guide wall after entering the lock forebay (Photo 38). However, aligning with the guide wall and entering the lock chamber could require considerable maneuvering and time. As the tow moved along the guide wall and approached the lock chamber, there was a tendency for the head of the tow to be moved toward the opening between the lock wall and the longitudinal dike. Upbound tows could leave the upper lock approach with no major difficulties with all flows up to 55,000 cfs (Photos 39 and 40). There was no tendency for an upbound tow to be moved away from the guide wall as observed in Plan D. The cells and longitudinal dike would provide safe conditions for navigation into the lock forebay with no danger of tows striking the upper end of the dike. Tows properly aligned two to three tow lengths upstream of the dike would drift into the lock approach. With the higher flows, considerable time and maneuvering would be required for tows to align with and enter the lock.

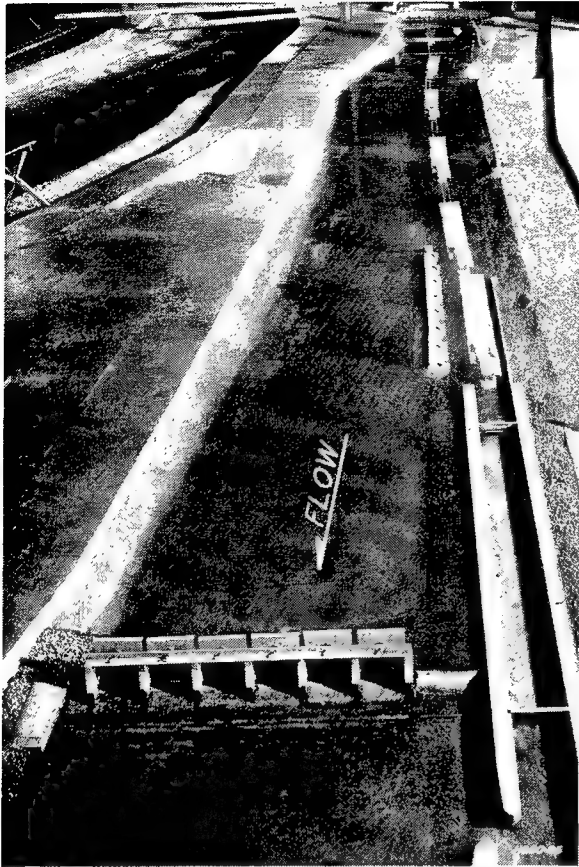
Photo 38. Plan D-Modified, looking upstream, discharge 55,000 cfs, showing path of downbound tow approaching lock. Note tow landing on guide wall by maneuvering in lock approach

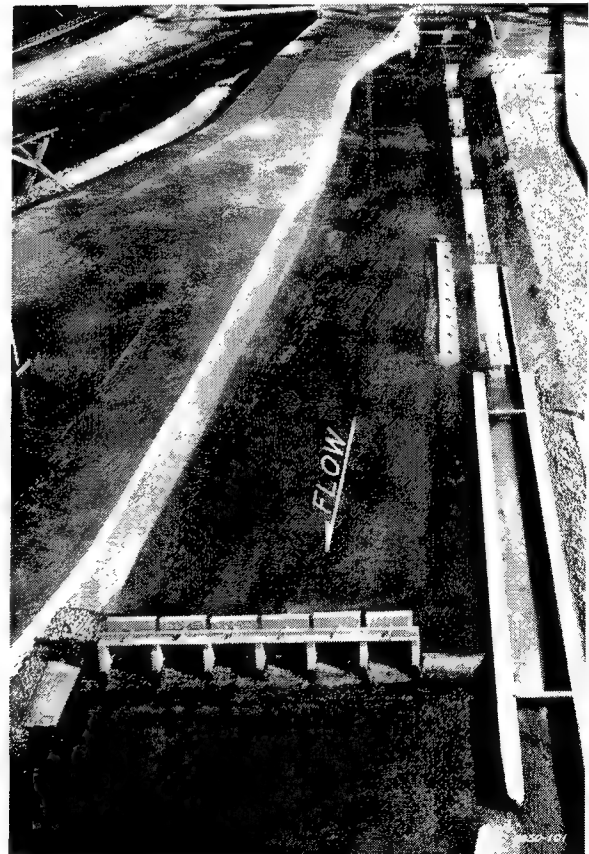
Photo 39. Plan D-Modified, looking upstream, discharge 22,500 cfs, showing path of upbound tow leaving lock

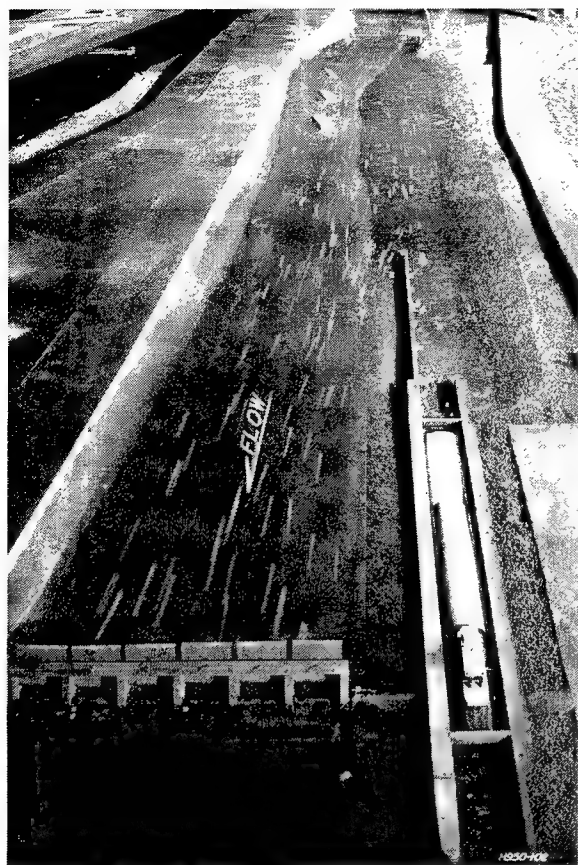
Photo 40. Plan D-Modified, looking upstream, discharge 55,000 cfs, showing path of upbound tow leaving lock

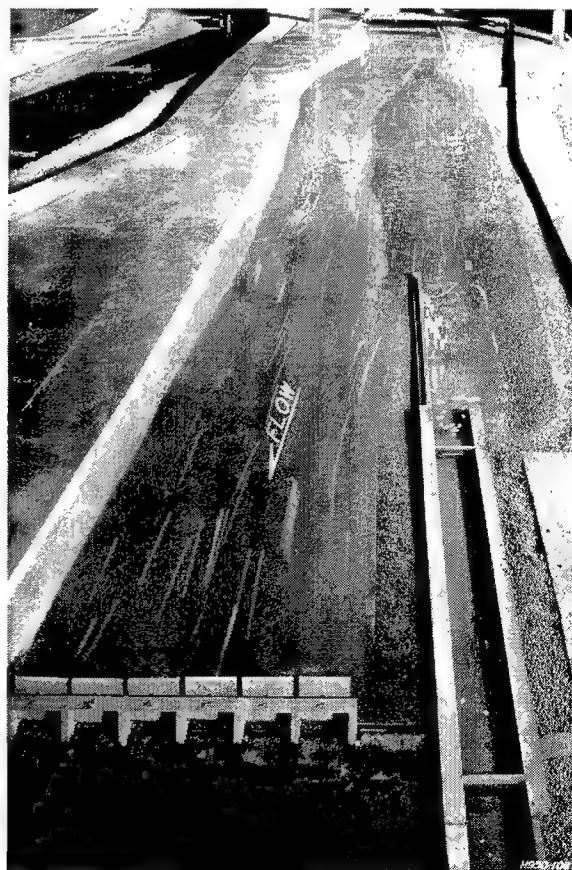
Photo 41. Plan E, looking upstream, discharge 22,500 cfs, confetti showing surface current patterns in upper lock approach

**Current directions and velocities.** Current direction and velocities obtained with Plan E are shown in Plates 16-18. Current patterns upstream of the dam are shown in Photos 41 and 42, and current patterns downstream of the dam are shown in Photos 43 and 44. These data indicate that the current generally followed the left bank from the upstream end of the model to the upstream end of the left bank excavation where the current tended to follow the main river channel. The vane dikes located near the right bank reduced the cross-sectional area of the river channel near the upstream end of the left bank excavation and moved the current into the excavated channel. The current was erratic in the vicinity of the vane dikes. However, this disturbance did not extend into the navigation channel approaching the lock. The maximum velocities of the current in the navigation channel varied from about 3.1 to 5.6 fps near the upstream mooring area, 3.3 to 6.1 fps about 1,500 ft upstream of the guard wall, and 2.2 to 3.7 fps near the upstream end of the guard wall. Current direction and velocity data shown in Plates 16-18 and current patterns shown in Photos 43 and 44 indicate the currents downstream of the dam were generally the same as with Plan B-Modified. These data indicate that the flow through the spillway moved between the vane dike near the end of the riverside lock wall and the vane dike near midchannel and across the lower lock approach at a steep angle. Some flow passed through the opening between the vane dike and the downstream end of the riverside lock wall. However, a small counter-clockwise eddy formed immediately downstream of the lock chamber with the 22,500- and 33,000-cfs riverflows. The velocity of the current in the eddy was generally less than 0.5 fps. The maximum velocities of the current near the downstream end of the guide wall varied from about 3.6 to 5.5 fps with the 22,500- and 55,000-cfs riverflows, respectively. The maximum velocities of the current in the navigation channel downstream of the lock varied from about 3.8 to 4.6 fps about 2,000 ft downstream of the dam and 3.6 to 4.2 fps about 4,000 ft downstream of the dam with the 22,500- and 55,000-cfs riverflows, respectively.

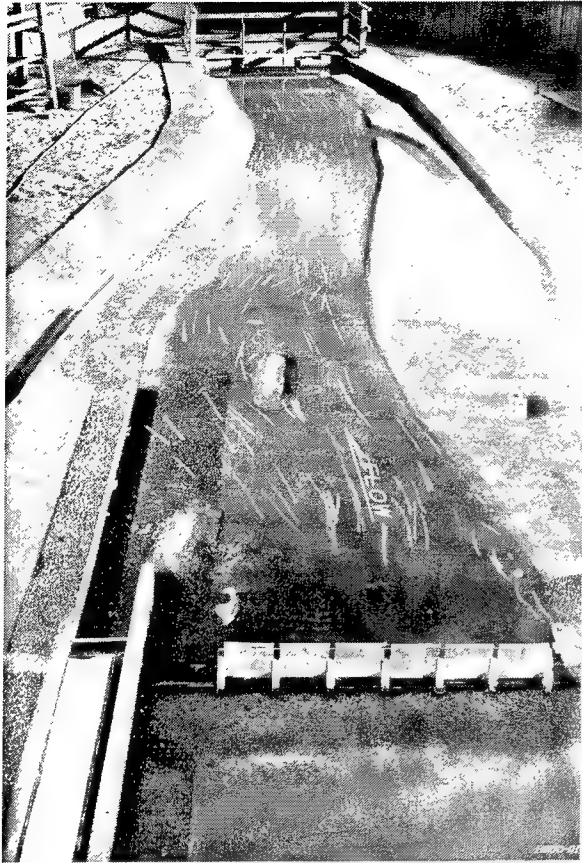
Photo 42. Plan E, looking upstream, discharge 55,000 cfs, confetti showing surface current patterns in upper lock approach

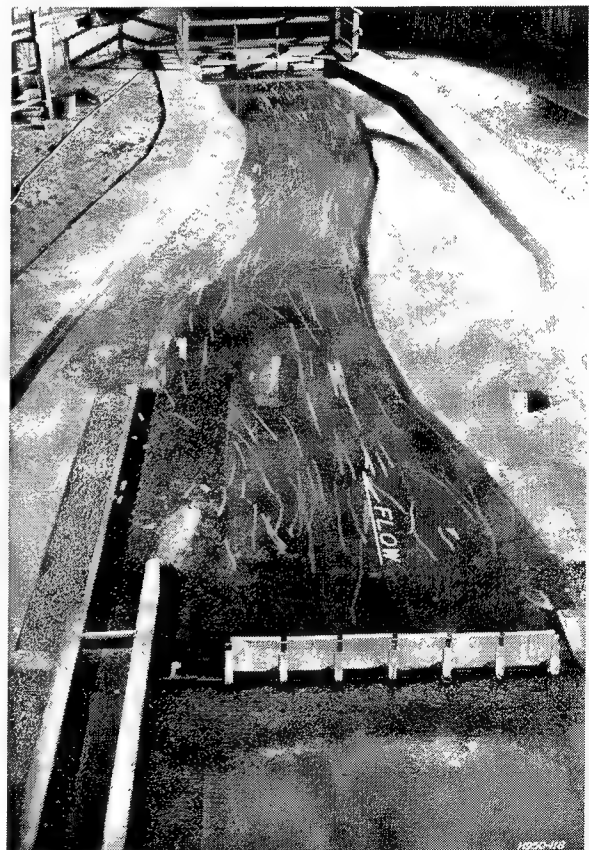
Photo 43. Plan E, looking downstream, discharge 22,500 cfs, confetti showing surface current patterns in lower lock approach

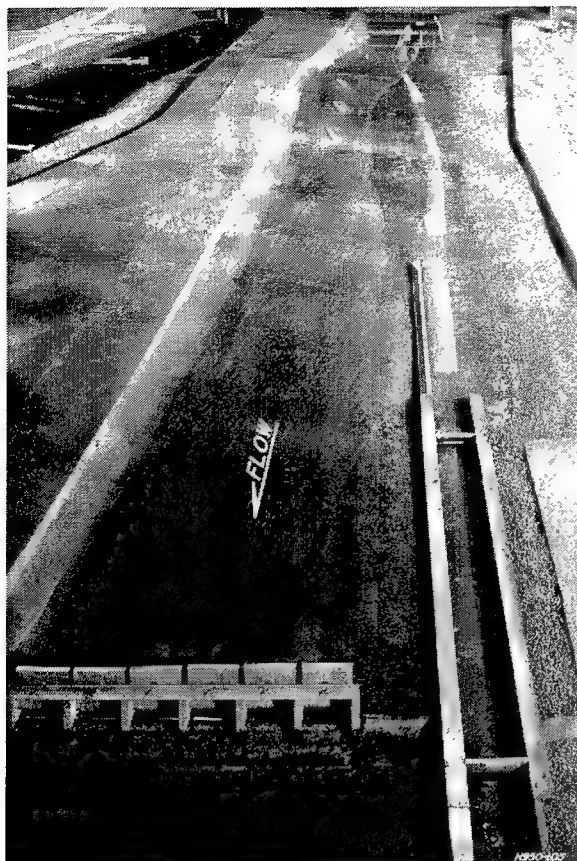
Photo 44. Plan E, looking downstream, discharge 55,000 cfs, confetti showing surface current patterns in lower lock approach

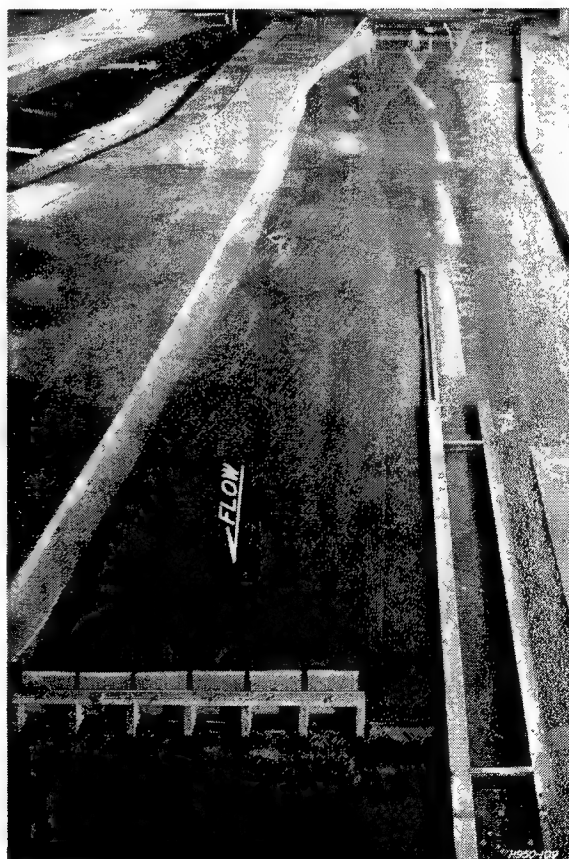
Photo 45. Plan E, looking upstream, discharge 22,500 cfs, showing path of downbound tow approaching lock

**Navigation conditions.** Navigation conditions were satisfactory for tows entering and leaving the upper lock approach with all riverflows up to the maximum navigable flow of 55,000 cfs (Photos 45-48). A downbound tow could enter the model reach from midchannel, drive into the excavated channel, align with the guard wall about two tow lengths upstream of the wall, start reducing speed, and enter the lock forebay at a safe speed with all riverflows through 55,000 cfs (Photos 45 and 46). The tow could make a slow approach to the guard wall without any tendency to be moved out of the approach or for the head of the tow to move into the wall with excess force. No difficulties were indicated for upbound tows leaving the lock. An upbound tow could move away from the guard wall and navigate upstream along the left bank or move out into the main channel without any difficulties (Photos 47 and 48). Although the design for the lower lock approach did not provide a full tow length of straight channel approaching the guide wall, navigation conditions for tows entering and leaving the lower lock approach were satisfactory with all flows. However, downbound tows were required to rotate the head of the tow away from the guide wall about 15 deg before leaving the lower approach. After rotating the head of the tow off the guide wall, the tow could drive away from the lower

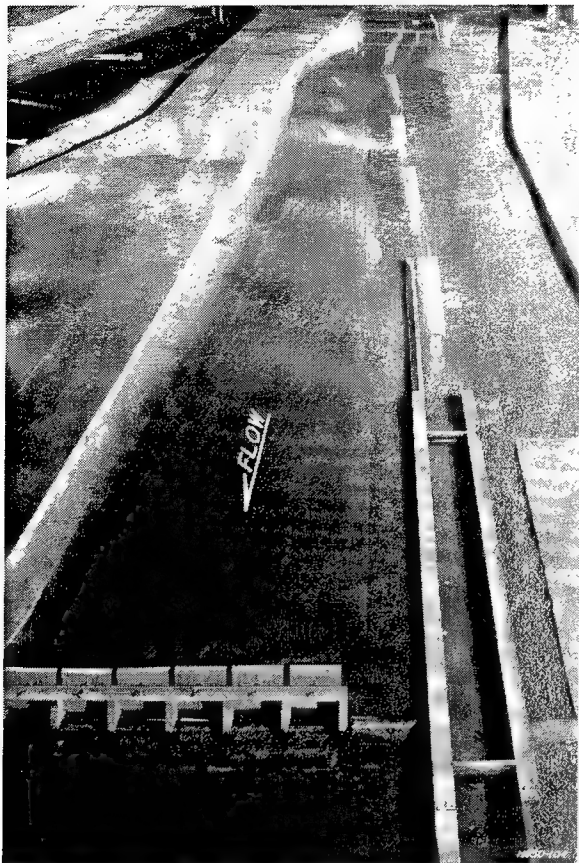
Photo 46. Plan E, looking upstream, discharge 55,000 cfs, showing path of downbound tow approaching lock

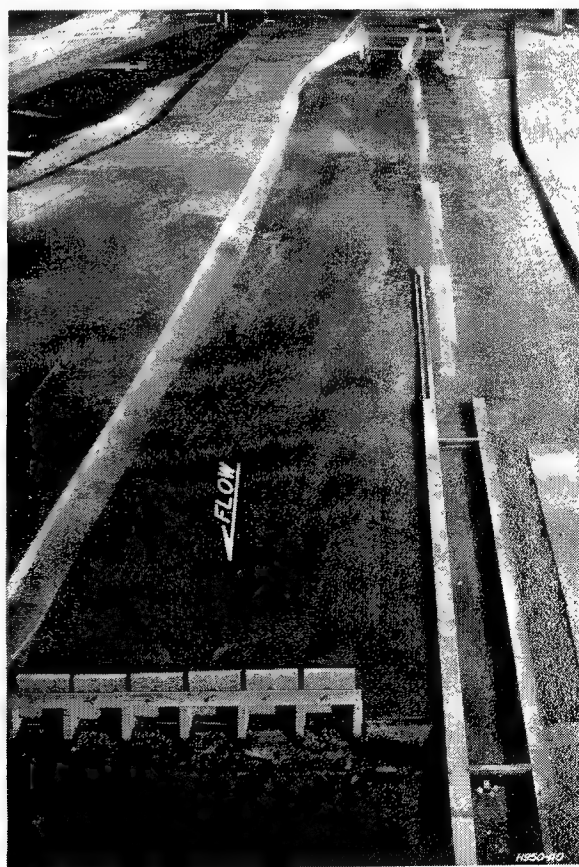
Photo 47. Plan E, looking upstream, discharge 22,500 cfs, showing path of upbound tow leaving lock

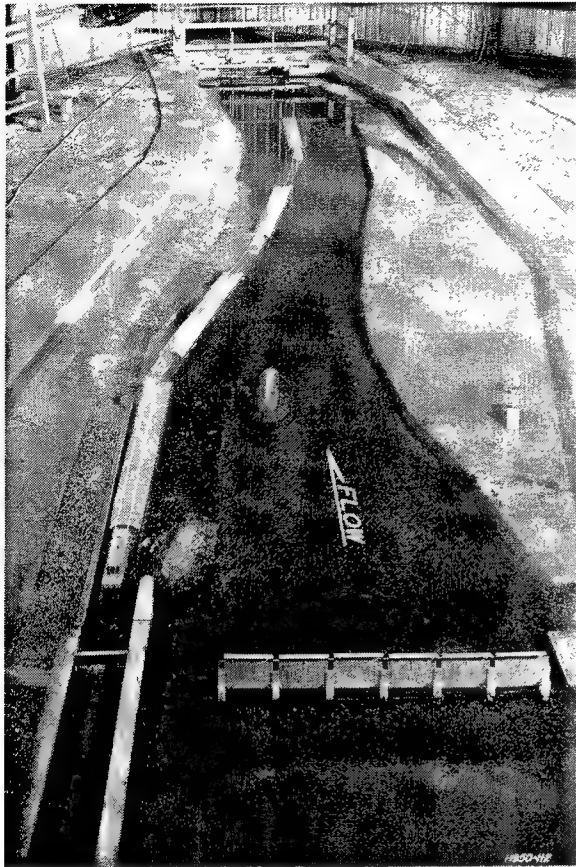
Photo 48. Plan E, looking upstream, discharge 55,000 cfs, showing path of upbound tow leaving lock

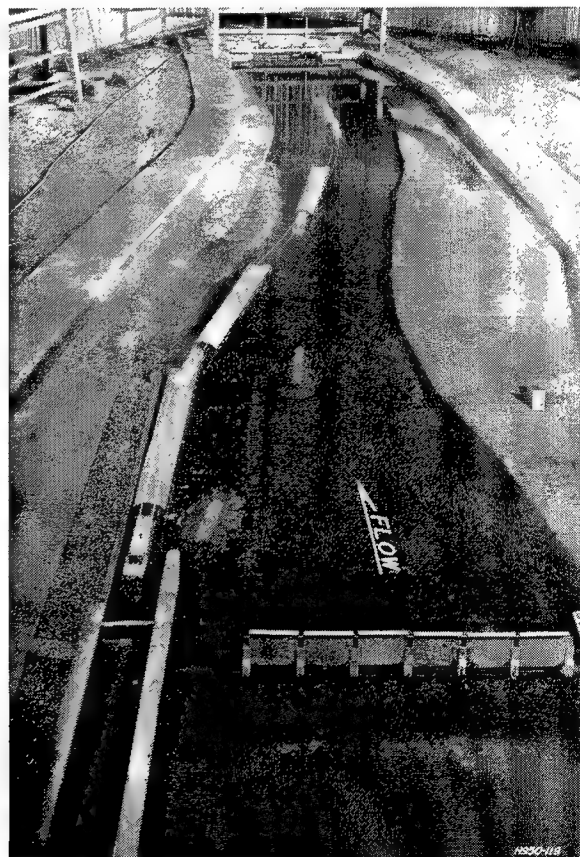
Photo 49. Plan E, looking downstream, discharge 22,500 cfs, showing path of downbound tow leaving lock

approach and enter the main channel without any difficulties (Photos 49 and 50). Maneuvering the head of the tow away from the guide wall would require additional time but was not a difficult maneuver. If the tow moved downstream without maneuvering the head of the tow off the wall, the clearance between the tow and the left bank was minimal for the tow to turn toward the main river channel. Upbound tows could leave the main river channel, align with the guide wall, and enter the lock chamber without any difficulties (Photos 51 and 52). There was no tendency for the head of the tow to move away from the guide wall as the tow entered the lock chamber.

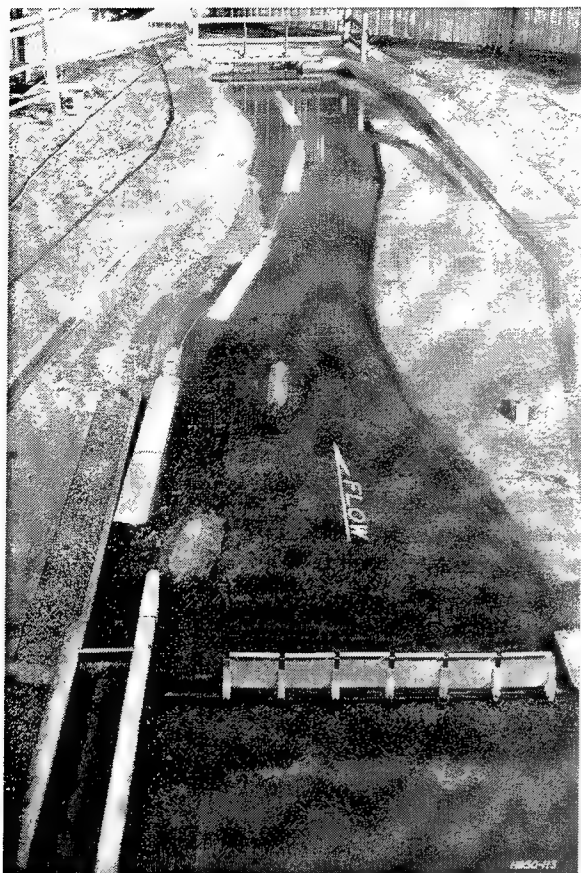
Photo 50. Plan E, looking downstream, discharge 55,000 cfs, showing path of downbound tow leaving lock

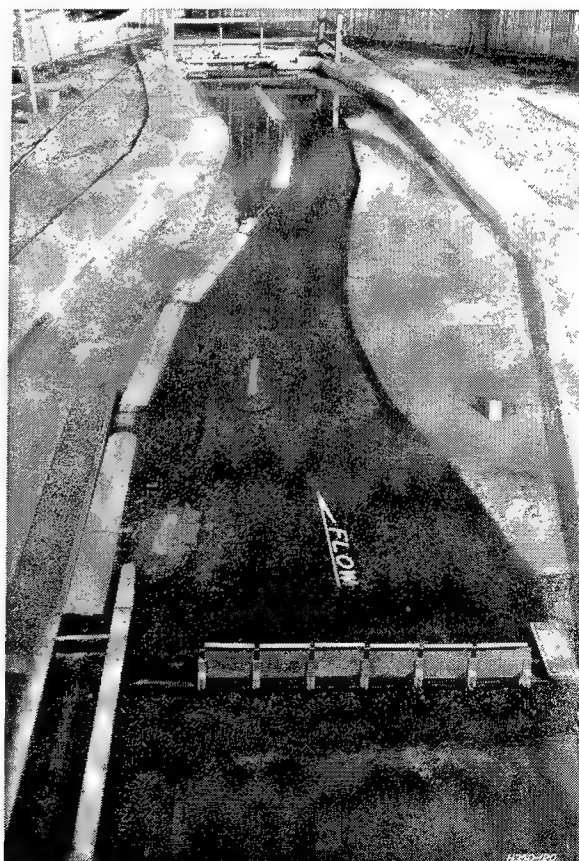
Photo 51. Plan E, looking downstream, discharge 22,500 cfs, showing path of upbound tow approaching lock

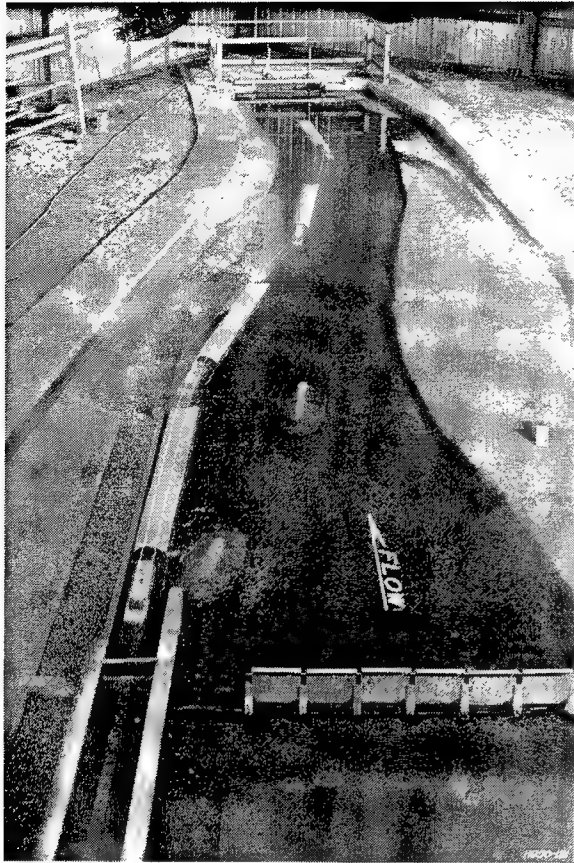
Photo 52. Plan E, looking downstream, discharge 55,000 cfs, showing path of upbound tow approaching lock

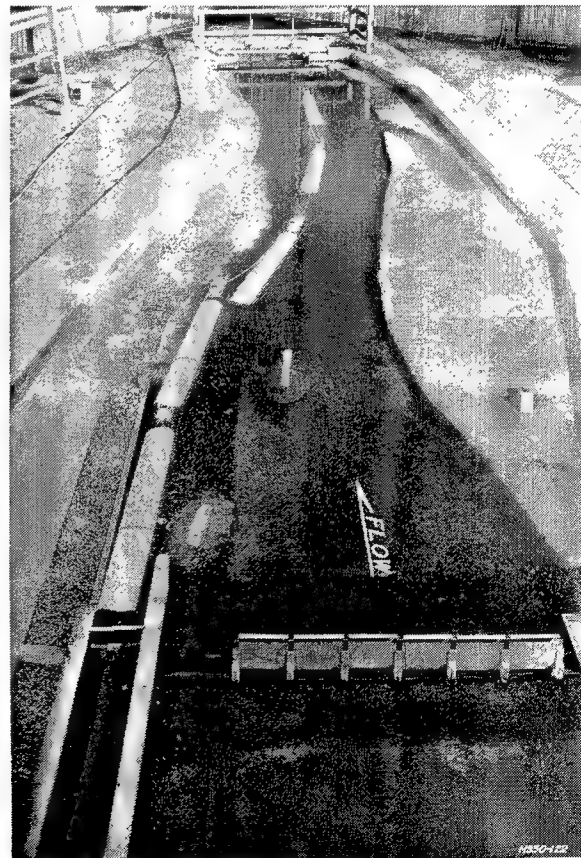
Photo 53. Plan E, drawdown conditions, looking downstream, discharge 55,000 cfs, showing path of downbound tow leaving lock

**Drawdown experiments.** Experiments were conducted with the model reproducing drawdown conditions as defined for Plan B-Modified. The experiments were conducted with the 22,500- and 55,000-cfs riverflows to determine any changes in navigation conditions or current patterns caused by the lower stages of a drawdown condition. During the drawdown experiments, dye and confetti were used to define the current patterns downstream of the dam. Observations of these current patterns were then compared with photographs of Plan E normal pool current patterns. This comparison indicated a slight change in the current alignment in the lower lock approach with the 22,500- and 55,000-cfs riverflows. Current direction and velocities measured with the 55,000-cfs riverflow are shown in Plate 21. These data indicate that the current pattern in the lower lock approach was generally the same as with normal tailwater conditions. However, lowering the tailwater increased the velocity of the currents. The maximum velocities of the currents with the 55,000-cfs riverflow varied from about 6.7 fps near the downstream end of the guide wall, to 6.3 fps about 2,000 ft downstream of the dam, and 6.3 fps about 4,000 ft downstream of the dam. However, navigation experiments with the model tow indicated no significant change in navigation conditions for tows leaving or entering the lower lock approach (Photos 53 and 54). Water-surface elevations measured with drawdown conditions are shown in Table 13. These data indicate a significant change in water-surface elevation due to the nature of the experiments. The drop through the dam varied from about 11.6 to 8.5 ft with the 22,500- and 55,000-cfs riverflows, respectively. The slope in water-surface elevation varied from about 0.1 to 0.4 ft per mile downstream of the dam with the 22,500- and 55,000-cfs riverflows, respectively.
